Limited Phase II Environmental Site Assessment

City Of Houston Former Fire Station #11
4520 Washington Avenue
Houston, Texas 77007

HRE PROJECT No. COH05-003

December 2005

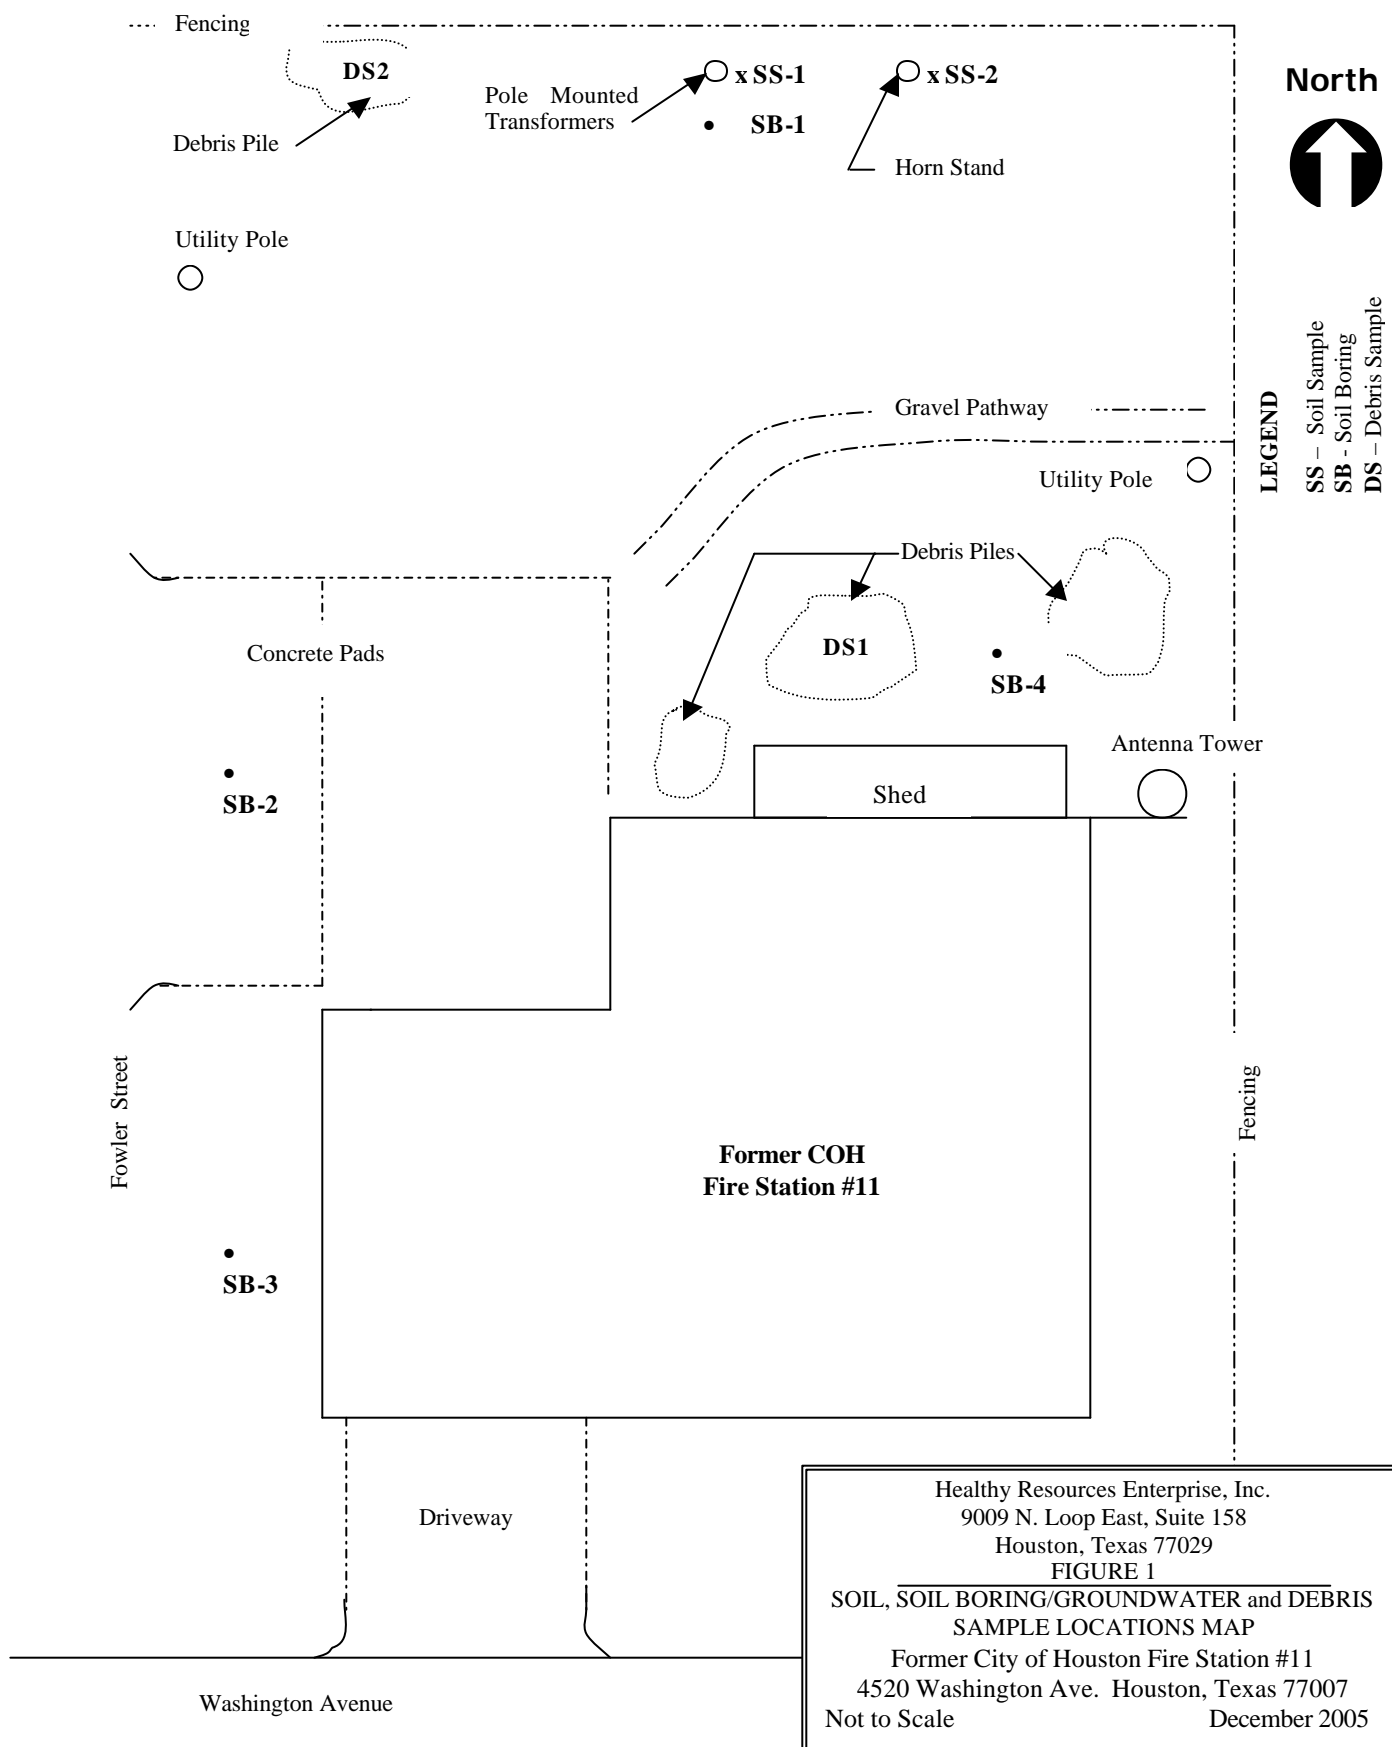
Figure 1
Soil, Soil Boring/Groundwater and Debris Sample Locations Map

The hand augured surface soil sample SS#1 result for Cadmium was 3.9 mg/kg; Lead was 218 mg/kg; and Mercury was 0.6 mg/kg. SS#1 is shown on Figure 1, Soil, Soil Boring/Groundwater and Debris Sample Locations Map. At these concentrations, SS#1 metals' results for Cadmium, Lead, and Mercury are above the Texas Risk Reduction Program (TRRP) Protective Concentration Limit (PCL) Tier I levels and/or the Texas –Specific Background Concentration at 0.75 mg/kg, 15 mg/kg, and 0.04 mg/kg, respectively. The remaining sampled parameters were reported at concentrations below TRRP Tier I PCLs and/or the Texas-specific Background Concentrations. **These elevated metals results may be the result of historic industrial land usage. Because of the elevated metals results in the surface soils, additional investigations including establishing site-specific soil background levels or considering remedial activities per the state's Voluntary Cleanup Program are options for COH.** Appendix D presents the laboratory analytical results and Appendix F, Table 2 presents the summary of the surface soil BETX, TPH and RCRA 8 metals sampling results.

SS#2 sample result for Aroclor 1254 was 0.0314 mg/kg, which is below the default PCB Tier I PCL at 5.3 mg/kg. As shown on Figure 1, Soil, Soil Boring/Groundwater and Debris Sample Locations Map, the SS#2 sample result was in the vicinity of the northeast section of the property, underneath the stand that supports the existing former emergency horn mechanical equipment. **Because there is the reported PCB result, additional investigation of the equipment and subsequent removal is warranted to alleviate potential future environmental concerns.** Appendix D presents the laboratory analytical results and Appendix F; Table 2 presents the summary of the surface soil PCB sampling results.

The four soil boring locations are shown on Figure 1, Soil, Soil Boring/Groundwater and Debris Sample Locations Map. BTEX and TPH were not detected in the soil samples from the four boring locations SB1 – SB4. However, metals data for soil boring SB1 (13'-14') exceeded the applicable comparative values for Arsenic, Barium, and Lead. Soil boring SB 4 (10'-12') sample results exceeded the applicable comparative values for Arsenic and Lead.

The four (4) groundwater samples were taken from the four soil boring locations shown on Figure 1, Soil, Soil Boring/Groundwater and Debris Sample Locations Map. The four (4) groundwater samples, MW-1 – MW-4, reported results for BTEX and TPH at non-detect and therefore, below the applicable TRRP Tier I PCLs for BTEX, TPH. However, the RCRA (8) metals reported results for MW-1 – MW-4 exceeded TRRP Tier I PCL groundwater values for Arsenic in MW-2, MW-3, and MW-4; Barium in MW-1 – MW-4; and Lead in MW-2 and MW-4. **These elevated metals results may be the result of historic industrial land usage. Because of the elevated metals results in the groundwater, additional investigations including establishing site-specific soil background levels or considering remedial activities per the state's Voluntary Cleanup Program are options for COH.** Appendix D presents the laboratory analytical results and Appendix F; Table 3 presents a summary of the groundwater BTEX, TPH, RCRA 8 metals and Total Dissolved Solids (TDS) sampling results.

The two waste piles and debris sample locations are shown on Figure 1, Soil, Soil Boring/Groundwater and Debris Sample Locations Map. The reported results for the TCLP Volatile Organic Analysis (VOA) and Acid, Base, Neutral (ABN) for both DS1 and DS2 were not detected. The TCLP metals results for both DS1 and DS2 were reported as below the reporting limit and below the EPA regulatory limit for hazardous wastes. The reactivity results reported for DS1 and DS2 were below the reporting limit and not-detected above regulatory limits. Therefore, the reported laboratory results for the two debris samples, DS1 and DS2, are non-

These elevated metals results may be the result of historic industrial land usage. Because of the elevated metals results in the subsurface soils, additional investigations including establishing site-specific soil background levels or considering remedial activities per the state's Voluntary Cleanup Program are options for COH. Appendix D presents the laboratory analytical results and Appendix F; Table 3 presents a summary of the soil boring BTEX, TPH and RCRA 8 metals sampling results.

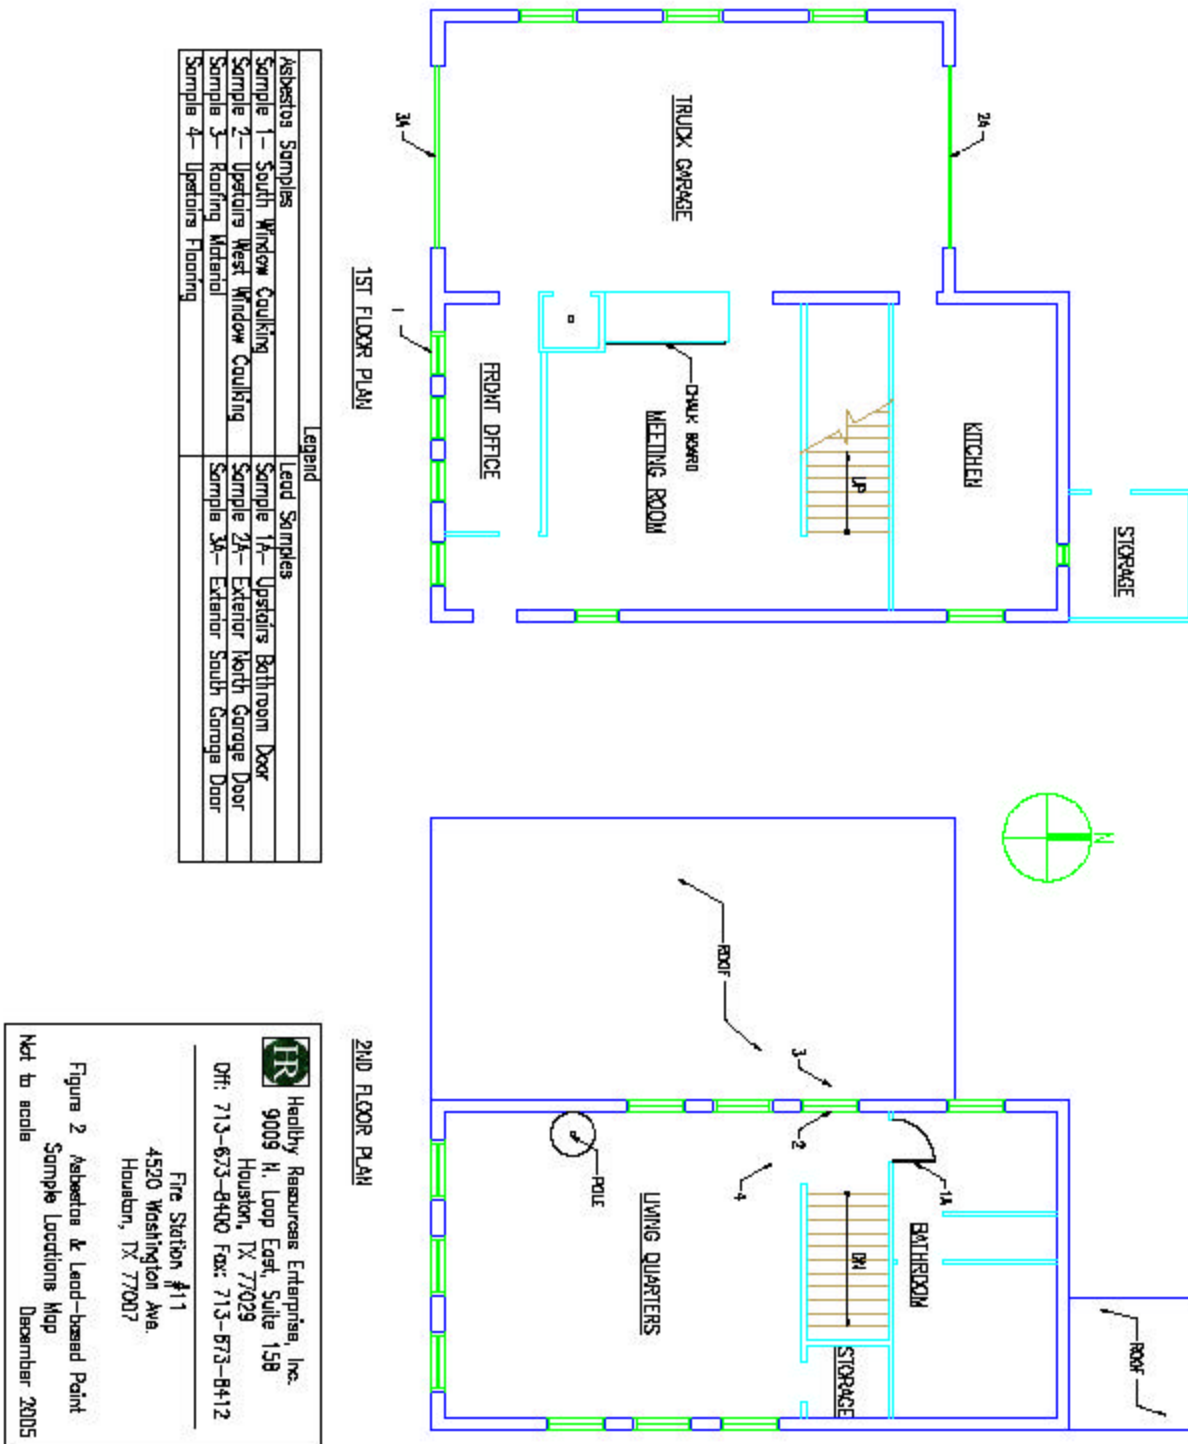
Figure 2
Asbestos and Lead-based Paint Sample Locations Map

Four (4) bulk samples were collected and analyzed for asbestos content during the asbestos survey. **From the 4 bulk samples collected, laboratory results indicated that friable ACM were present in Sample 1, window caulking, at 5% Chrysotile.** Other assumed ACM include the existing black chalk board located in the meeting room and any existing heating, ventilation and air conditioning (HVAC) duct and mastic and/or piping insulation that were inaccessible in the ceiling during the HRE asbestos survey conducted on November 9, 2005. Potential inaccessible asbestos materials should be addressed during planned building renovation or demolition activities. The asbestos sample locations are shown on Figure 2, Asbestos and Lead-based Paint Sample Locations Map. Appendix E presents the laboratory analytical results and Appendix F; Table 4 presents a summary of the asbestos sampling results.

A Niton XRF analyzer was utilized for field examination of painted surfaces so as to quickly determine those surfaces free from lead-based paint and therefore, to identify potential components suspected of containing lead-based paint for bulk sampling. Based on the XRF readings included in Appendix E, three (3) lead-based paint bulk samples, one each, were taken from the exterior of the North Garage Door (Sample 1A; layers of dark brown, light grey and dark green paint); exterior of the South Garage Door (Sample 3A; layers of beige, dark brown, light grey and dark green paint); and the interior upstairs door painted with dark green (Sample 2A). Samples 1, 2 and 3 were submitted to EMSL Analytical, Inc. for Lead TCLP analysis to determine the proper waste management of lead-based paint building materials. The lead concentrations reported by the laboratory were as follows: Sample 1A, 29 milligrams per liter (mg/L); Sample 2A, 95 mg/L and Sample 3A, 150 mg/L. The lead-based paint results for the subject building materials are 6 to 30 times greater than the EPA’s 5 mg/L concentration for acceptable landfill disposal. The subject lead concentrations are considered as Class I Hazardous for disposal purposes. The lead sample locations are shown on Figure 2, Asbestos and Lead-based Paint Sample Locations Map. Appendix E

The City of Houston has an approved “Asbestos Hazard Classification Protocol”. Based on the aforementioned asbestos findings, including the laboratory analysis, HRE observations, assumptions, and existing site conditions (deterioration of building materials, potential for disturbance and accessibility), the appropriate COH Response Actions under the approved “Asbestos Hazard Classification Protocol” are “C-2: Asbestos Present; Health Hazard, as defined by EPA, Abatement should be planned” and/or “C-3: Asbestos Present; No action necessary unless renovation, remodeling, or demolition is planned”.

The City of Houston has an approved “Lead-based Paint Hazard Classification Protocol”. Based on the aforementioned lead findings, including the laboratory analysis, HRE observations, assumptions, and existing site conditions (deterioration of building materials, potential for disturbance and accessibility), the appropriate COH Response Action under the approved “Lead-based Paint Hazard Classification Protocol” is “C-1: Lead Present; Health Hazard, as defined by applicable Federal, State and city regulations. Abatement should be a top priority ($\geq 5,000$ ppm or 0.5% by weight or $1\text{mg}/\text{cm}^2$).”
